Nomination for URBAN Award

Elder Park Rotunda

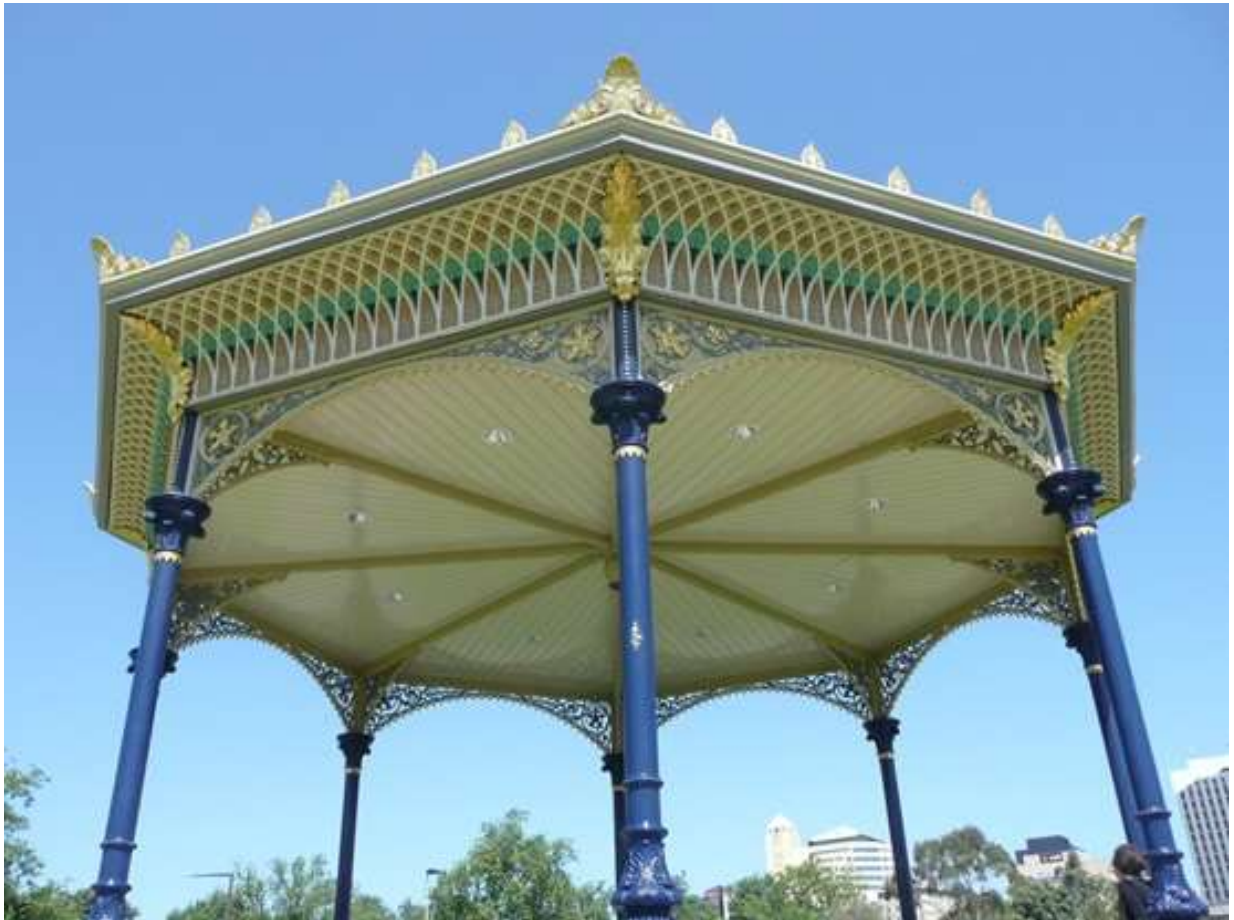
The Elder Park Rotunda, an important historic structure forming a central part of the Elder Park and River Torrens precinct and listed on the South Australian Heritage Register, was in need of restoration, as significant rust and damage had developed, compounded by poor workmanship in the past. Several parts of the balustrading were also broken or missing.

In 2014, restoration was undertaken at a high standard consistent with modern materials, techniques and trade practices without compromising the cultural significance of the structure and retaining the original fabric wherever possible.

The works included high quality detailed re-painting, including the roof and re-gilding of numerous items including antefixa, finial and ornamental flowers. All cast iron works had to be repaired and rust-treated. Repairs included casting of decorative balustrade pieces, replacing all broken and missing pieces, repairing and welding of existing guttering and roof and detailed restoration of the finial.
